## **Close Out Documents**

### **AP-74 – 4610 Clayton St.**

Asbestos Abatement and Structural Demolition

**Structure Survey Assessment Report AP-74**

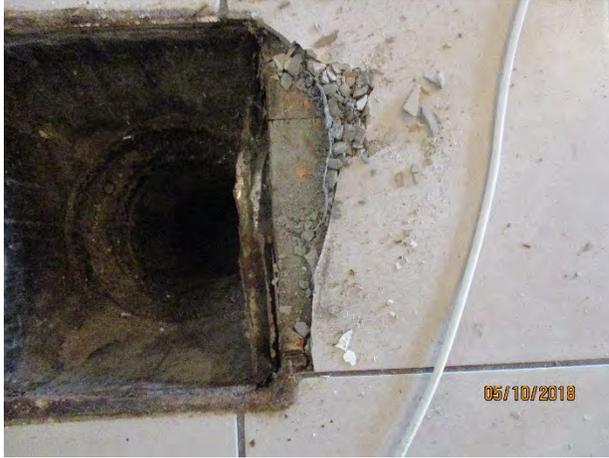
Vent Wrap

Samples Represented –  
4610CL-R7-12A  
4610CL-R4-12B

Approximately 25 square feet of RACM was identified as vent wrap located on the supply registers for the heating/air conditioning system. These materials will require abatement due to being rendered friable easily prior to demolition of the structures.

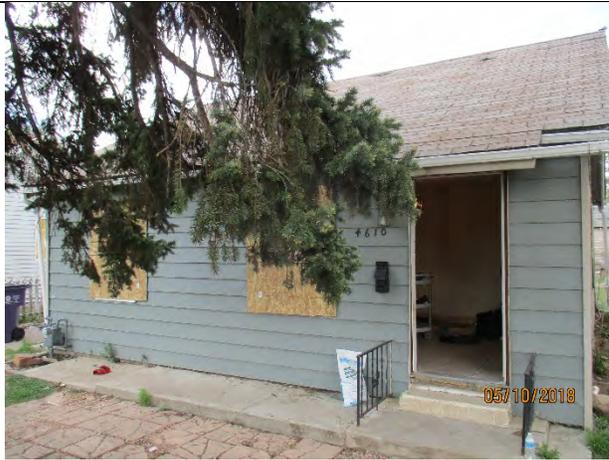
Roofing Mastic-House

Samples Represented –  
4610CL-EX-17A  
4610CL-EX-17B

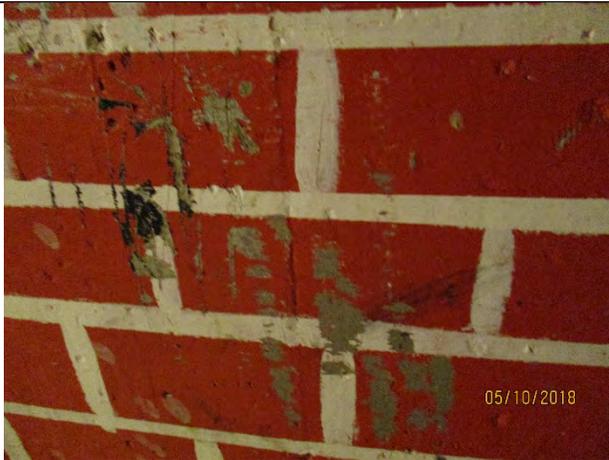
LCP – Black/Red/White

Sample Represented –  
4610CL-11L

One lead samples (4610CL-11L) was found to be greater than 0.06% by weight and less than 0.5% by weight and is considered LCP. Three samples (4610CL-12L, 4610CL-13L & 4610CL-14L) had lead concentrations greater than 0.5% by weight and is considered LBP (Table 3-2). The remaining 10 samples were less than the LCP and LBP thresholds, and are considered non-lead containing paint (NLC). The laboratory analytical report is included in Appendix D.

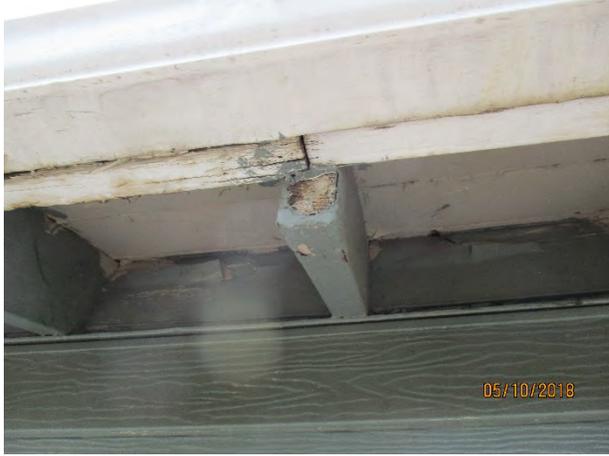
LBP – Gray

Sample Represented –  
4610CL-12L

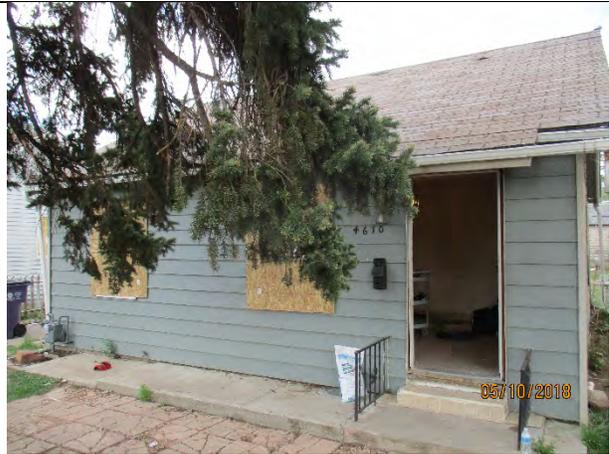
LBP – Tan (Front Step & Trim)

Sample Represented –  
4610CL-13L

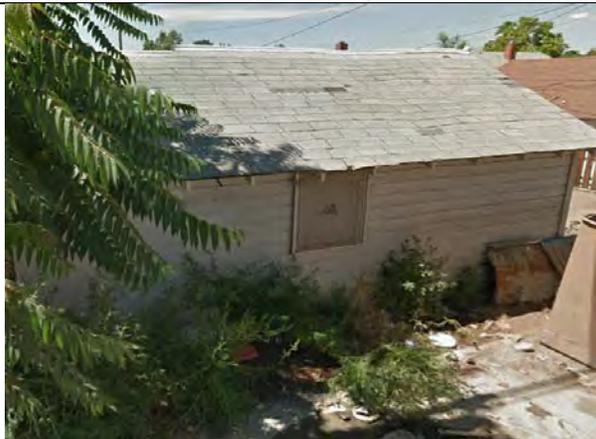
LPB – Tan (Garage)

Sample Represented –  
4610CL-14L
